Title: Remedial Work (short peripheral overlaps)	Products: All Firehalt barriers	Fix Detail : # 12
		Version: 1
		Date: 18/12/2017

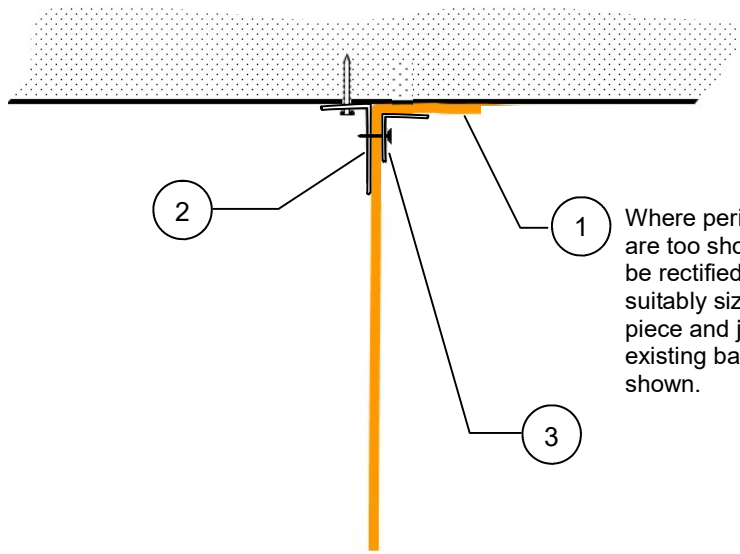
Where peripheral overlaps are too short the detail can be rectified by adding a suitably sized barrier insert piece and joining to the existing barrier panel as shown.

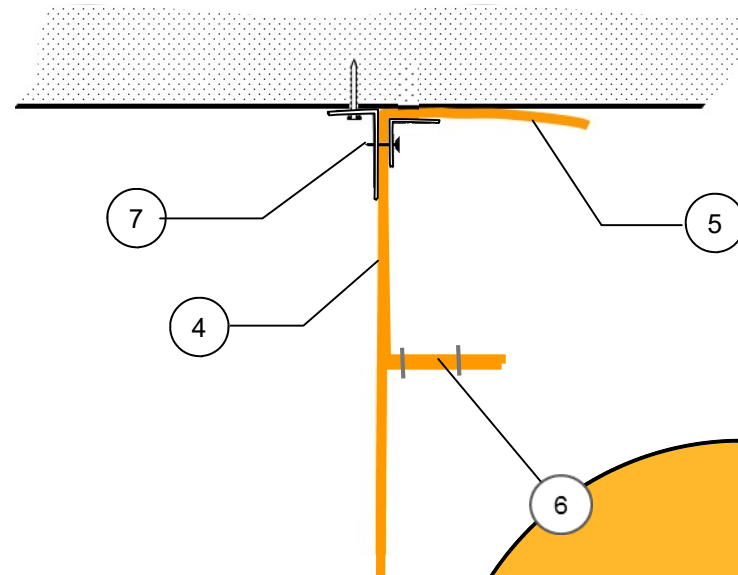
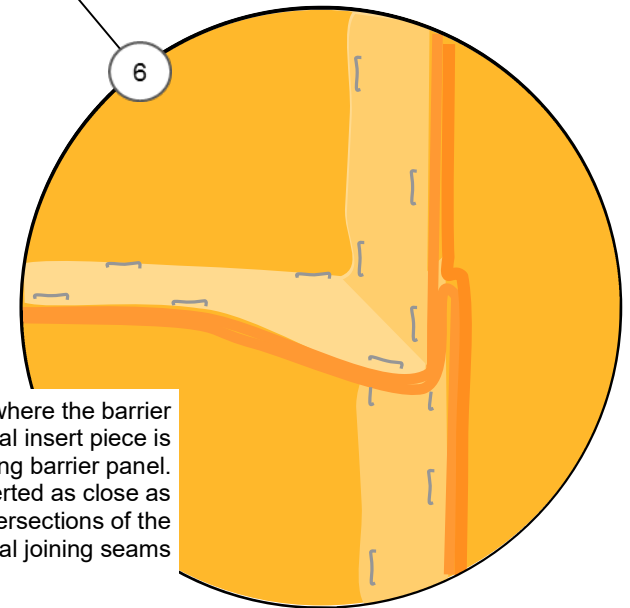
Vertical joint detail where the barrier panel with a remedial insert piece is rejoined to the existing barrier panel. Staples must be inserted as close as possible to the intersections of the horizontal/vertical joining seams
